**From:** DeBruyn, Dana (DEQ)  
**Sent:** Tuesday, November 24, 2015 2:32 PM  
**To:** Busch, Stephen (DEQ); Madziar, Joseph (LARA)  
**Subject:** pierce rough draft  
**Attachments:** Photo Album Pierce.pptx; Pierce Elementary School draft.docx

**Pierce Elementary School  
Outlet Sampling and Plumbing Assessment  
Recommendations  
1101 West Vernon Drive, Flint, Michigan 48503**

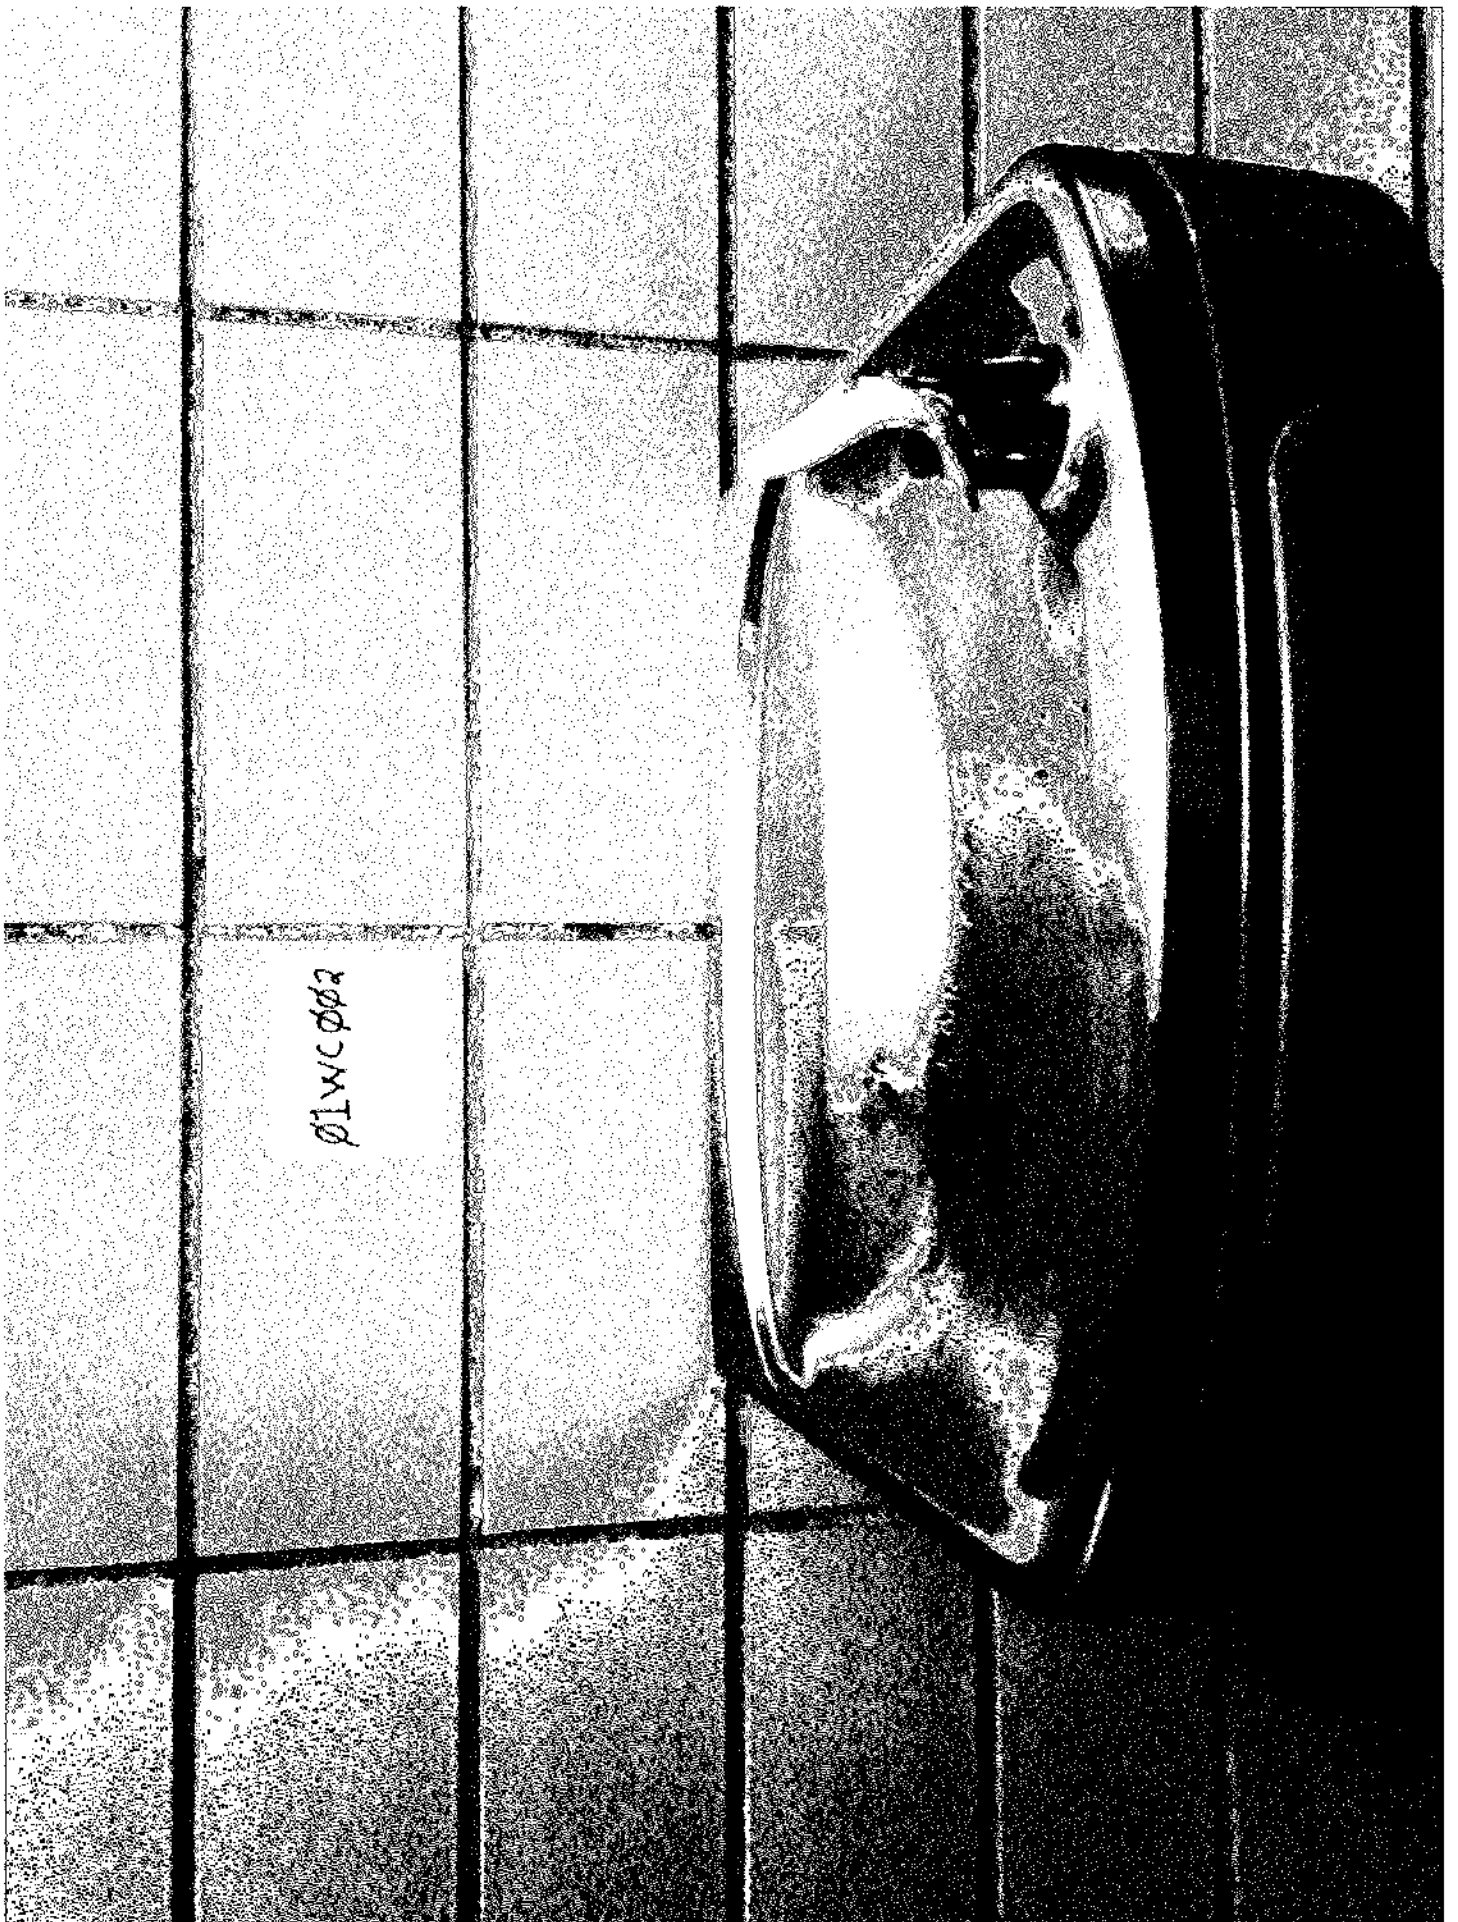
ø1WCøø2

**Outlet: Water Cooler Fountain (01WC002)**  
**Location:** Hallway north corridor, next to Mechanical Room  
**Results:** P1=8 parts per billion, P2=13 parts per billion,  
 F01=35 parts per billion, F02=19 parts per billion

These results suggest the lead may be from the water cooler unit and the connecting plumbing. The water cooler is an Elkay model. This model may contain brass components. Connecting plumbing to the cooler unit may also contain brass components.

This water cooler fountain should not be used. The entire unit and connecting plumbing should be replaced.

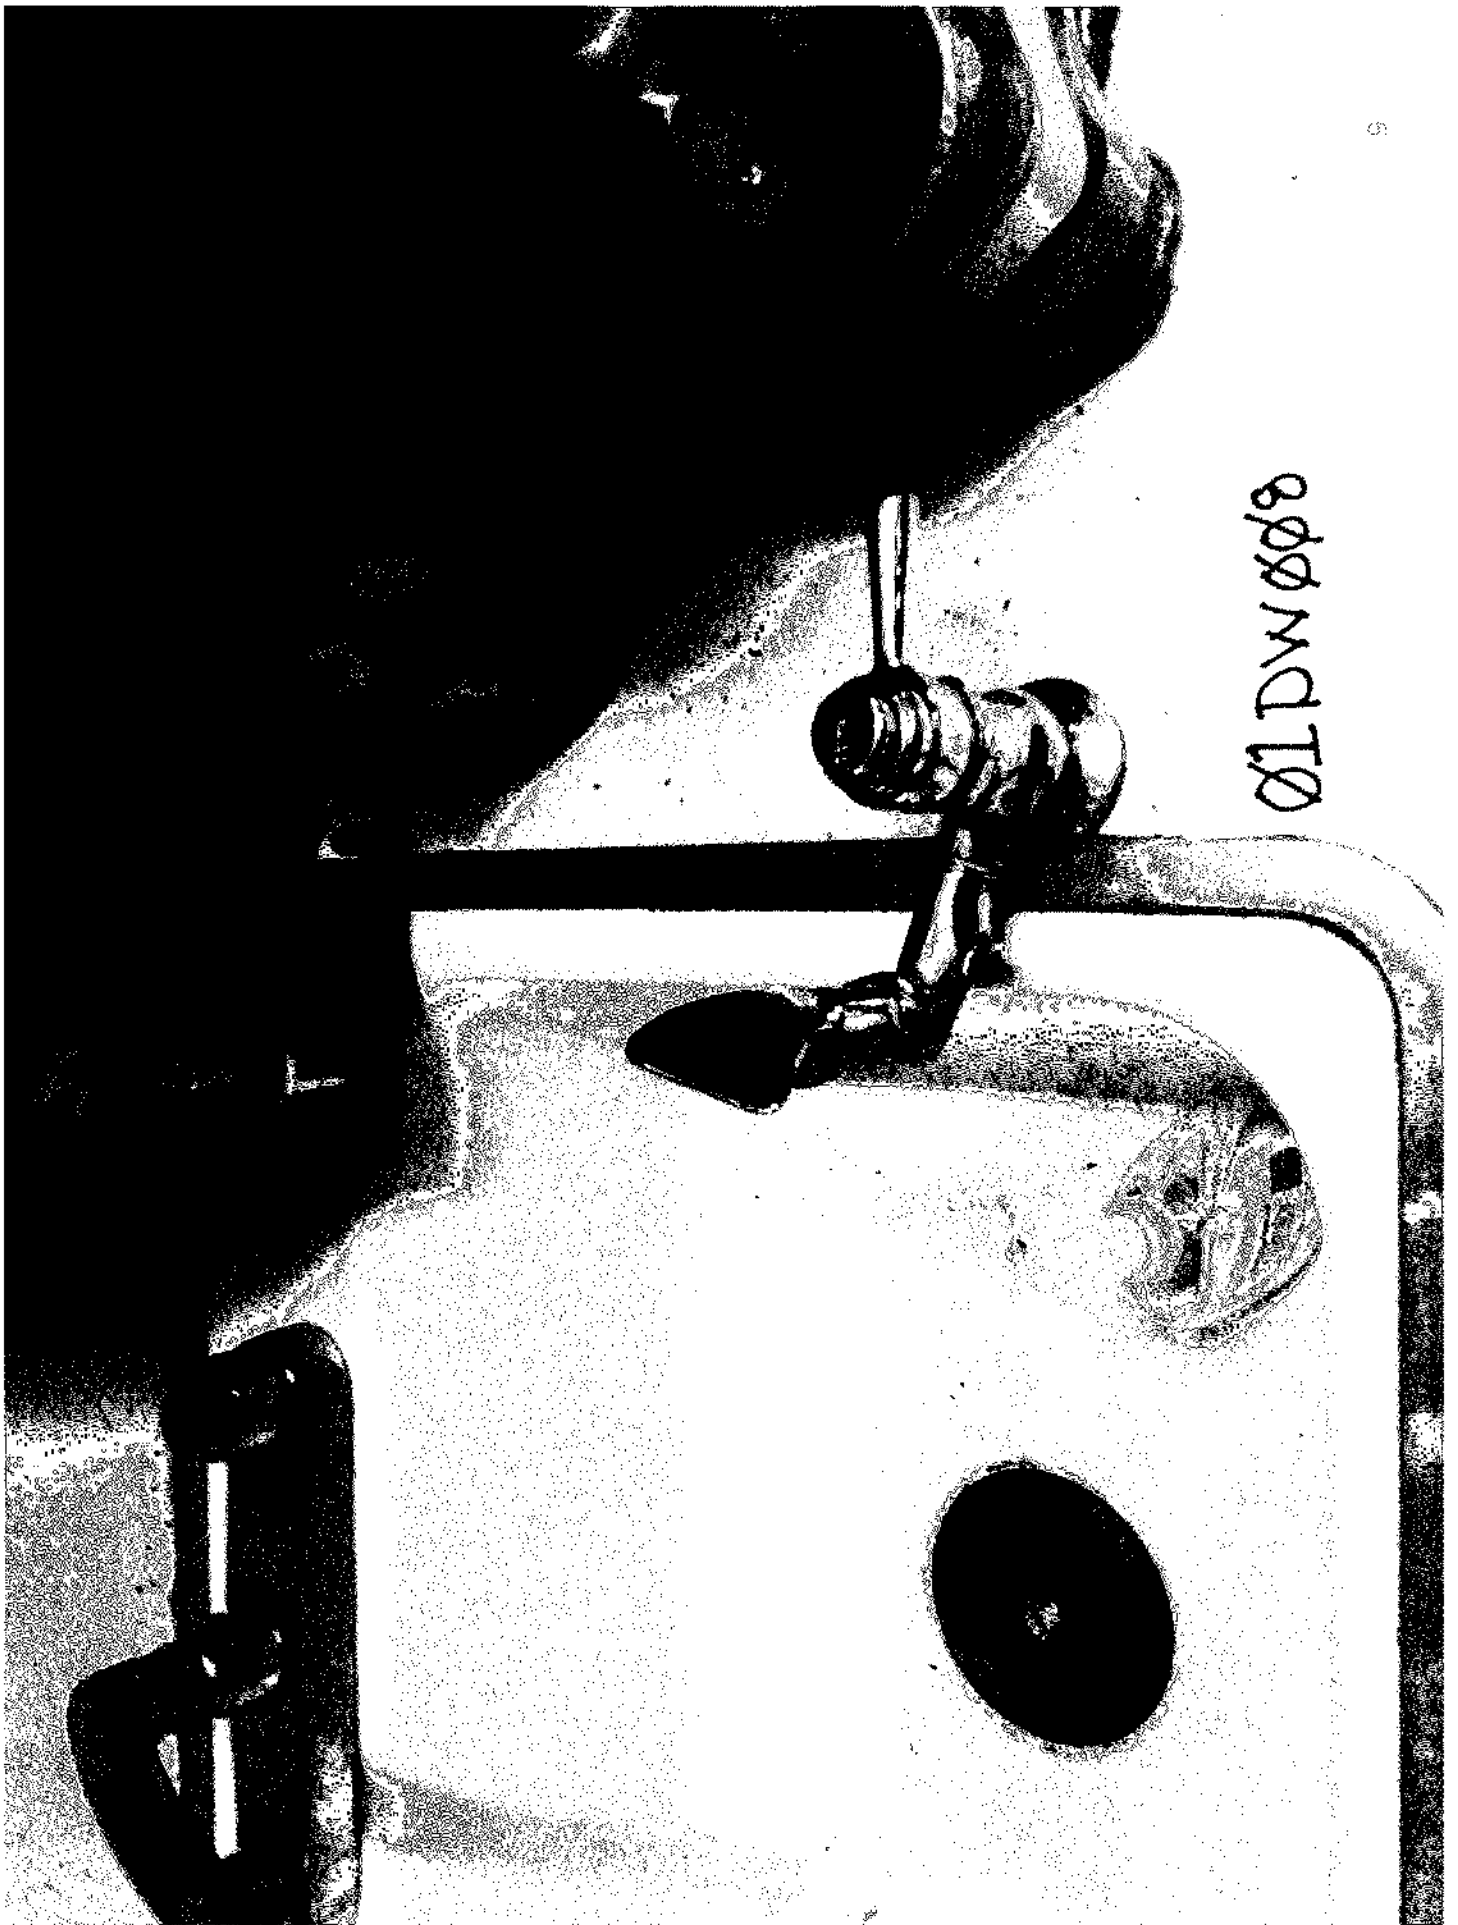
Ø1DWØØ8

Results: P1=468 parts per billion, P2=75 parts per billion,  
F01=6 parts per billion, F02=4 parts per billion

These results suggest the highest contribution of lead may be from the bubbler and its connecting plumbing. This bubbler fixture is made of chrome-plated brass and has a brass connector on the underside of the sink. Connecting plumbing in the cabinet under the sink should be checked for brass components and copper piping with lead solder.

Replacement of this bubbler tap and its connection plumbing with lead-free materials will significantly reduce lead exposure at this location. If replacement is not currently feasible,

sample results indicate that flushing this tap for 3 minutes following periods of stagnation is likely to reduce lead concentrations and lead exposure.

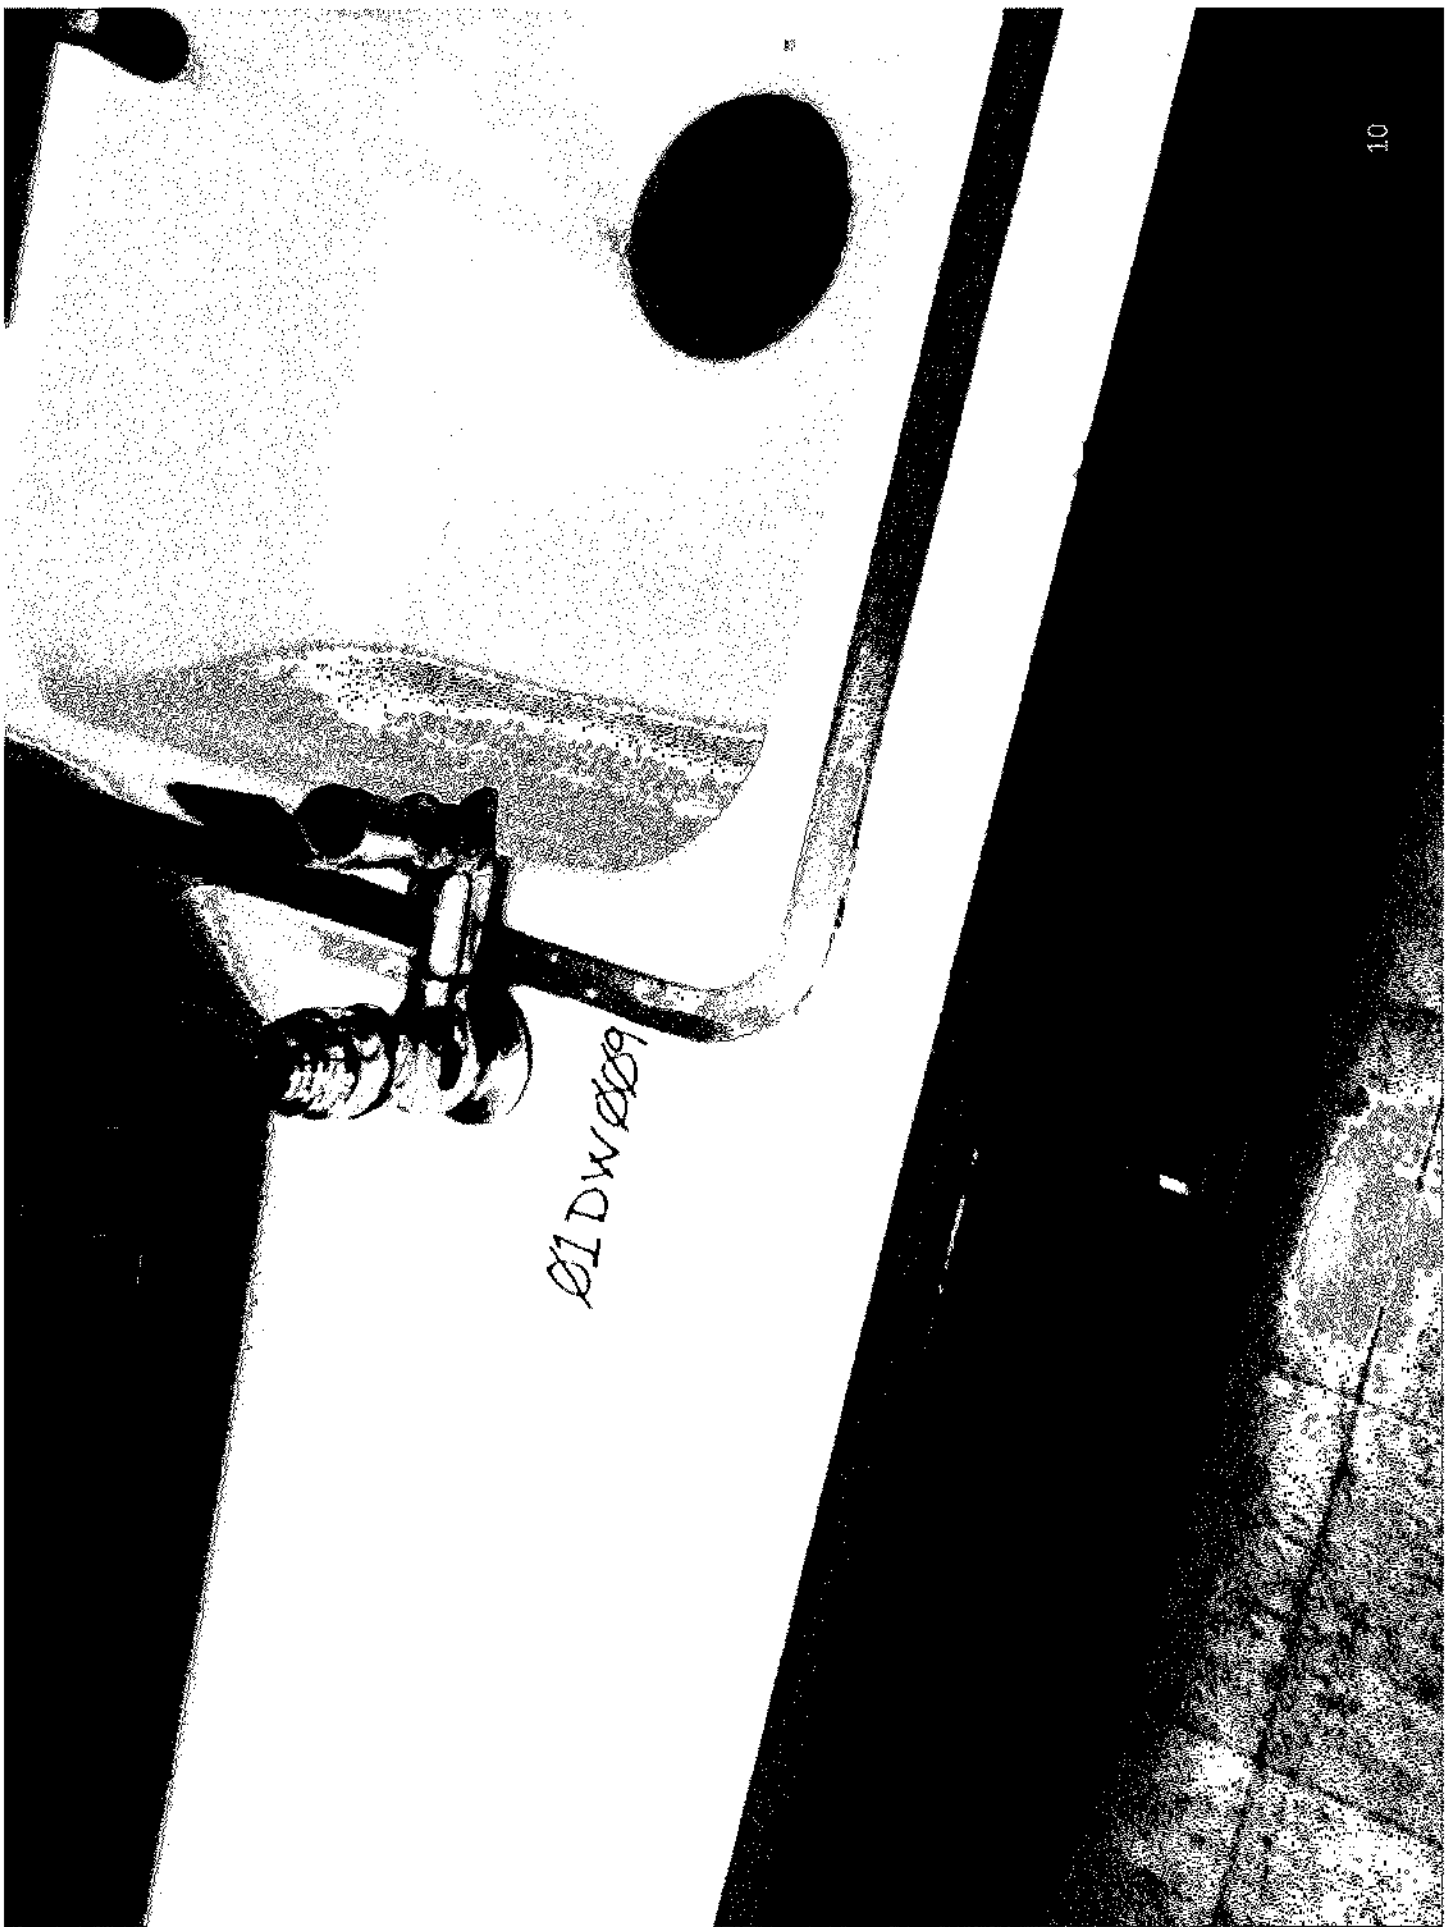
01 DW 009

Results: P1=26 parts per billion, P2=38 parts per billion,  
F01=7 parts per billion, F02=3 part per billion

These results suggest the highest contribution of lead may be from the bubbler and its connecting plumbing. This bubbler fixture is made of chrome-plated brass and has a brass connector on the underside of the sink. Connecting plumbing in the cabinet under the sink should be checked for brass components and copper piping with lead solder.

Replacement of this bubbler tap and its connection plumbing with lead-free materials will significantly reduce lead exposure at this location. If replacement is not currently feasible, sample results indicate that flushing this tap for 3 minutes following periods of stagnation is likely to reduce lead concentrations and lead exposure.

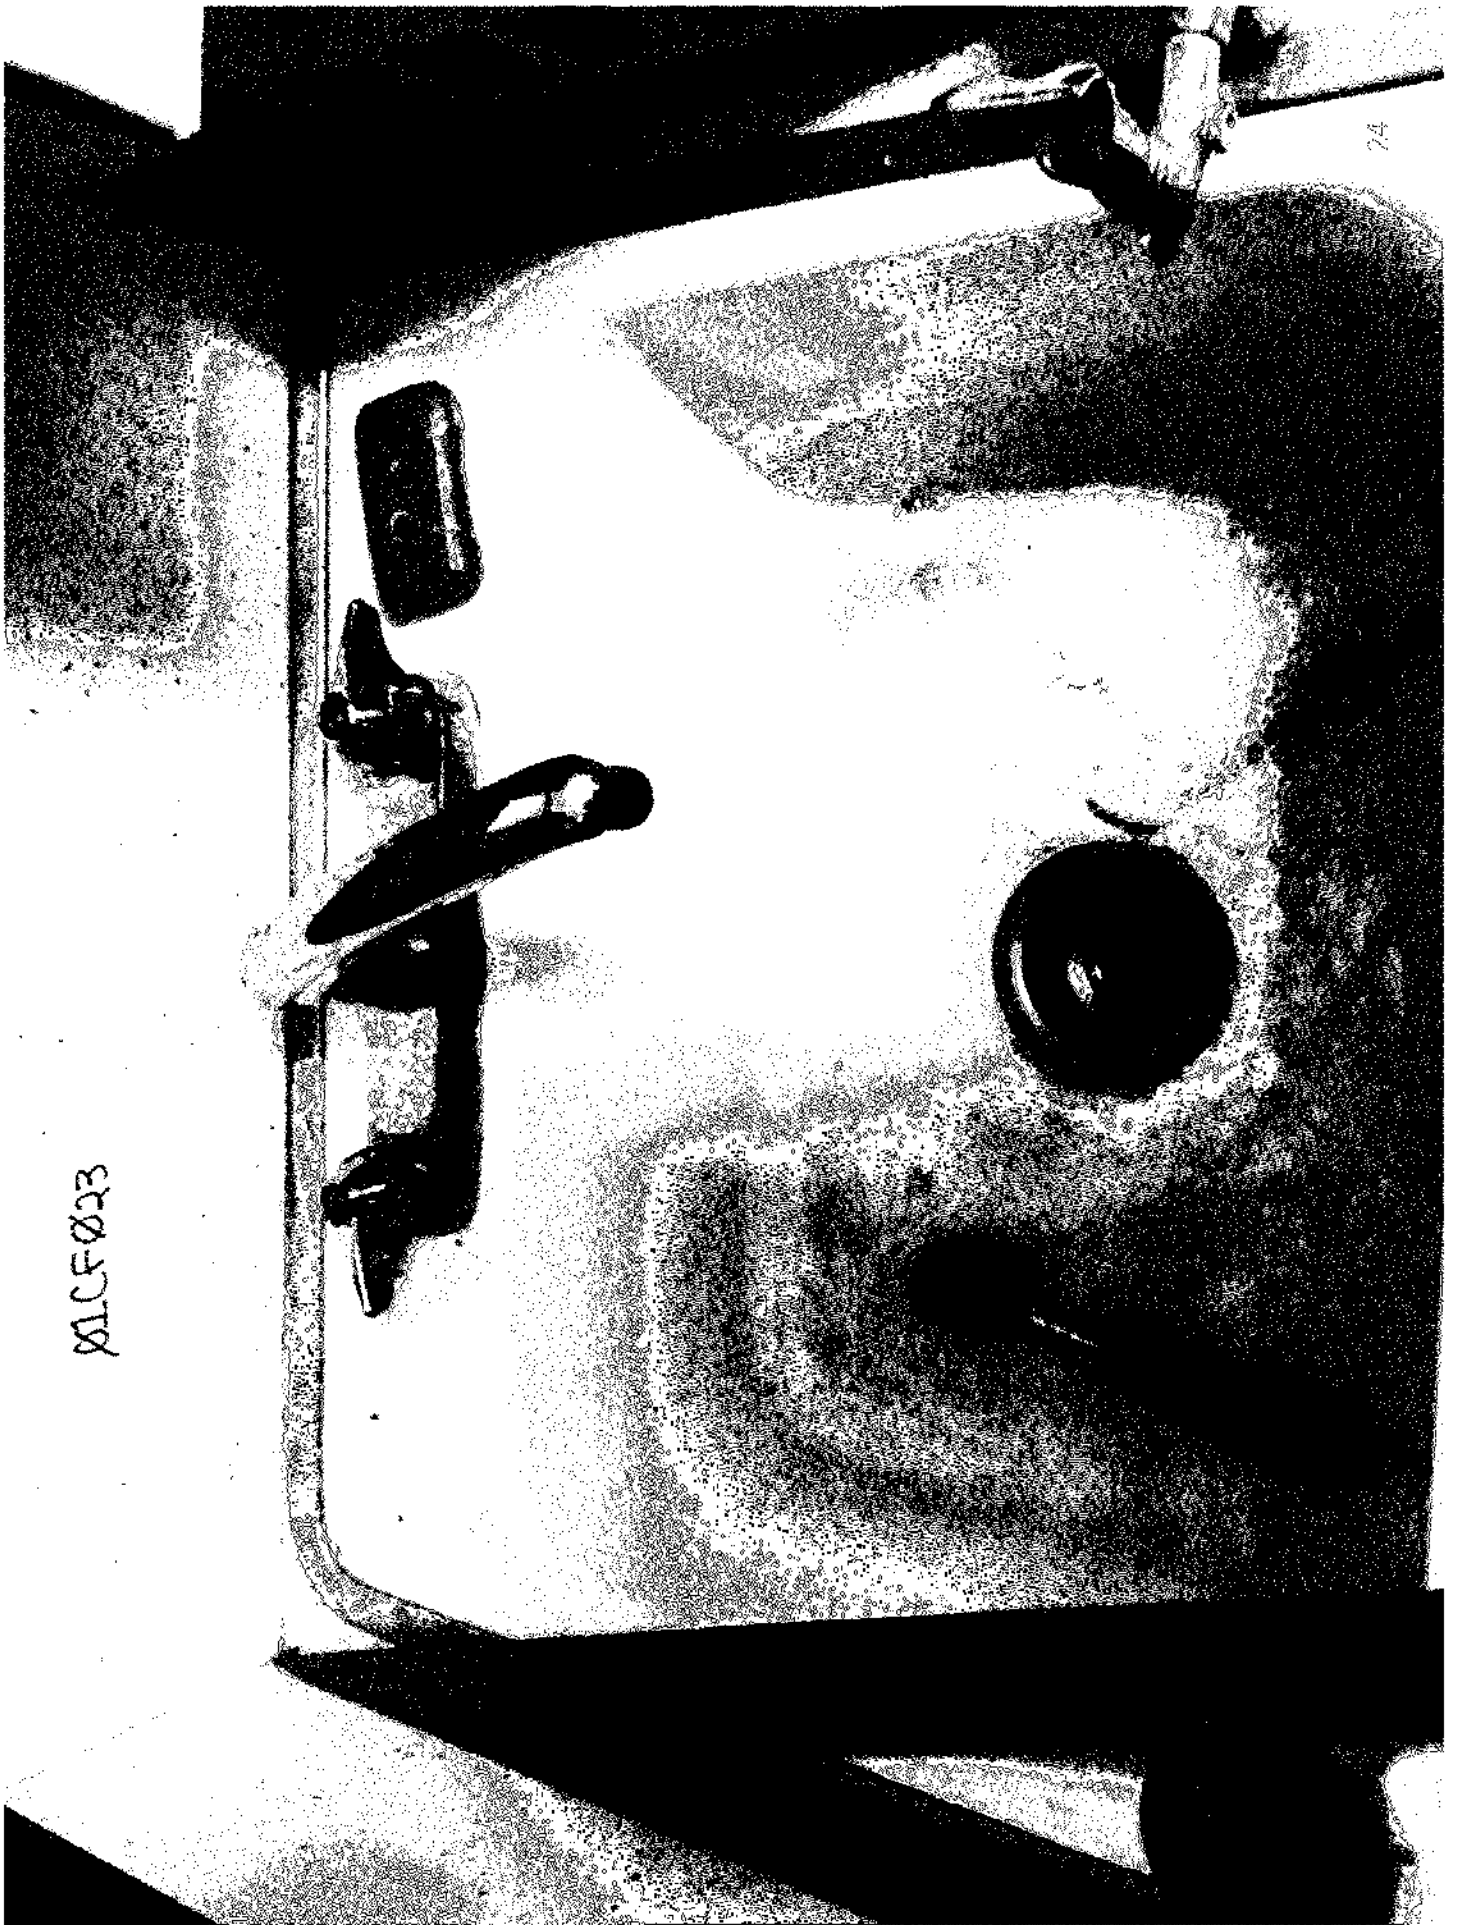
81CF-023

Results: P1=22 parts per billion, P2=14 parts per billion,  
F01=9 parts per billion, F02=6 parts per billion

Replacement of this faucet and its connection plumbing with lead-free materials will significantly reduce lead exposure at this location. If replacement is not currently feasible, sample results indicate that flushing this tap for 3 minutes following periods of stagnation is likely to reduce lead concentrations and lead exposure.
