## Flint Drinking Water Action Plan Update

## MICHIGAN DEPARTMENT OF ENVIRONMENTAL QUALITY FLINT DRINKING WATER EVENTS TIMELINE

## **Outlet Sampling and Plumbing Assessment Recommendations**

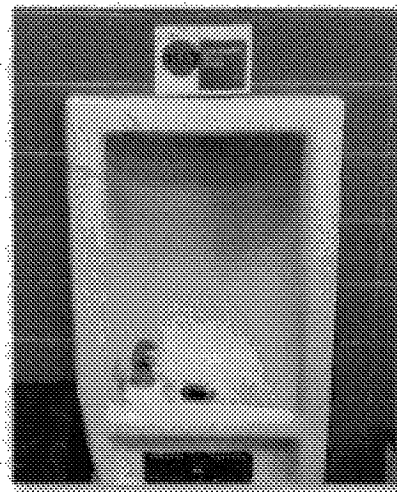
These results suggest the highest contribution of lead may be from the bubbler itself. This bubbler fixture is made of chrome plated brass and is believed to have a brass valve. The connection piping with the unit may also contain some brass components.

Replacement of this bubbler tap and its connection plumbing with lead-free materials will significantly reduce lead exposure at this location. If replacement is not currently feasible, sample results indicate that flushing this tap for 3 minutes following periods of stagnation is likely to reduce lead concentrations and lead exposure.

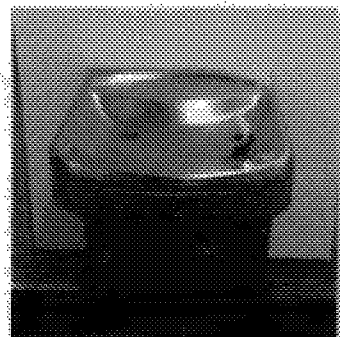
**Outlet: Water Cooler Fountain (01WC002)**

Location: Hallway between Gym and Auditorium, northeast side

These results suggest the highest contribution of lead may be from the water cooler unit. The water cooler is an Elkay model LKEZFS8. This model contains some brass components. Connecting plumbing to the cooler unit may also contain brass components.

Replacement of the entire unit is recommended and will significantly reduce lead exposure at this location. If replacement is not currently feasible, sample results indicate that flushing this tap for 3 minutes following periods of stagnation is likely to reduce lead concentrations and lead exposure.

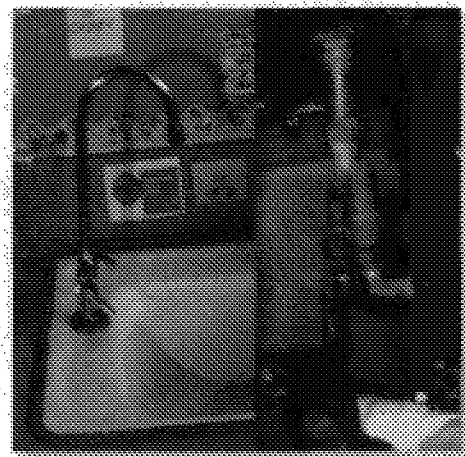
**Outlet: Sink Faucet (01CF004)**

Location: Classroom 109, northwest wall

These results suggest the highest contribution of lead may be from the faucet and its connecting plumbing. The base of this faucet is chrome plated brass, and has a brass connection on the underside of the sink. Hot and cold water lines connect to this faucet with a brass mixer fitting under the sink. Connecting plumbing in the cabinet under the sink may also contain additional brass components.

Replacement of this faucet and its connection plumbing with lead free materials will significantly reduce lead exposure at this location. If replacement is not currently feasible, sample results indicate that flushing this tap for 3 minutes following periods of stagnation is likely to reduce lead concentrations and lead exposure.

This faucet also has an aerator/screen at the outlet. If the faucet is not replaced, the aerator/screen should be removed, inspected for particulate accumulations, scrubbed clean, and reinstalled. If particulates are found, the aerator/screen should be periodically checked and cleaned.

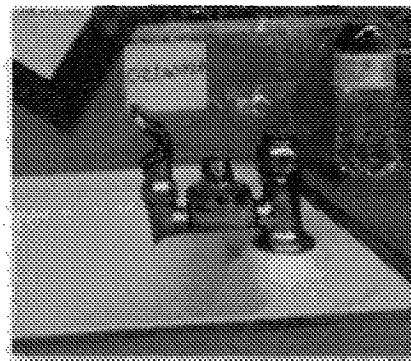
**Outlet: Bubbler Fountain (02DW020)**

Results: P1=37 parts per billion, P2=24 parts per billion  
F01=2 parts per billion, F02=non-detect

These results suggest the highest contribution of lead may be from the bubbler and its connecting plumbing. This bubbler fixture is made of chrome plated brass and has a brass connector on the underside of the sink. The bubbler also has a chrome plated brass flow regulator installed between the operating valve and the outlet. The connecting plumbing is copper with lead solder and includes a brass shut off valve.

Replacement of this bubbler tap and its connection plumbing with lead-free materials will significantly reduce lead exposure at this location. If replacement is not currently feasible, sample results indicate that flushing this tap for 3 minutes following periods of stagnation is likely to reduce lead concentrations and lead exposure.

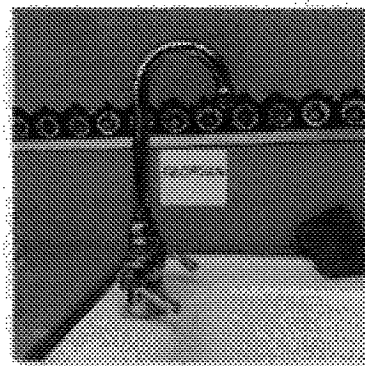
**Outlet: Sink Faucet (02CF022)**

Results: P1=7 parts per billion, P2=24 parts per billion  
F01=2 parts per billion, F02=1 part per billion

These results suggest the highest contribution of lead may be from the faucet and its connecting plumbing. The base of this faucet is chrome plated brass, and has a brass connection on the underside of the sink. Connecting plumbing in the cabinet under the sink is made up of brass connectors; copper piping with lead solder and brass shut off valves.

Replacement of this faucet and its connection plumbing with lead free materials will significantly reduce lead exposure at this location. If replacement is not currently feasible, sample results indicate that flushing this tap for 3 minutes following periods of stagnation is likely to reduce lead concentrations and lead exposure.

This faucet also has an aerator/screen at the outlet. If the faucet is not replaced, the aerator/screen should be removed, inspected for particulate accumulations, scrubbed clean, and reinstalled. If particulates are found, the aerator/screen should be periodically checked and cleaned.

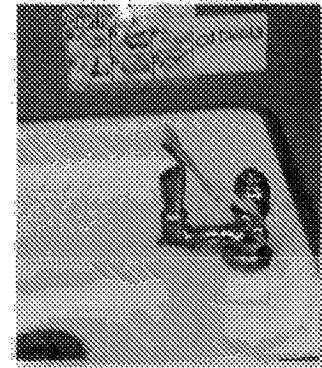
Results: P1=43 parts per billion, P2=106 parts per billion  
F01=3 parts per billion, F02=2 parts per billion

These results suggest the highest contribution of lead may be from the bubbler and its connecting plumbing. This bubbler fixture is made of chrome plated brass and has a brass connector on the underside of the sink. Connecting plumbing in the cabinet under the sink is made up of brass connectors; copper piping with lead solder, and a brass shut off valve.

Replacement of this bubbler tap and its connection plumbing with lead free materials will significantly reduce lead exposure at this location. If replacement is not currently feasible, sample results indicate that flushing this tap for 3 minutes following periods of stagnation is likely to reduce lead concentrations and lead exposure.

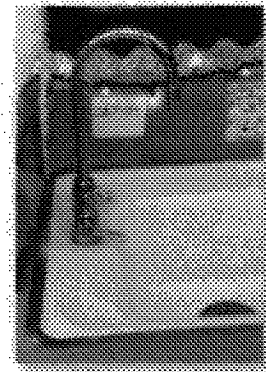
**Outlet: Sink Faucet (01CF014)**

Results: P1=36 parts per billion, P2=36 parts per billion  
F01=2 parts per billion, F02=1 part per billion

These results suggest the highest contribution of lead may be from the faucet and its connecting plumbing. The base of this faucet is chrome plated brass, and has a brass connection on the underside of the sink. Connecting plumbing in the cabinet under the sink is made up of brass connectors; copper piping with lead solder and brass shut off valves.

Replacement of this faucet and its connection plumbing with lead free materials will significantly reduce lead exposure at this location. If replacement is not currently feasible, sample results indicate that flushing this tap for 3 minutes following periods of stagnation is likely to reduce lead concentrations and lead exposure.

This faucet also has an aerator/screen at the outlet. If the faucet is not replaced, the aerator/screen should be removed, inspected for particulate accumulations, scrubbed clean, and reinstalled. If particulates are found, the aerator/screen should be periodically checked and cleaned.

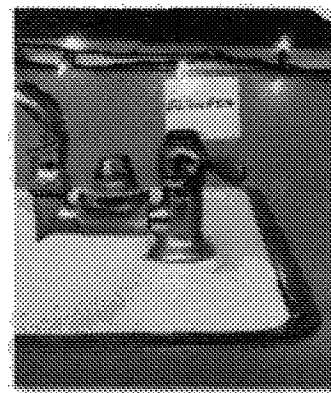
Results: P1=18 parts per billion, P2=8 parts per billion  
F01=2 parts per billion, F02=1 part per billion

These results suggest the highest contribution of lead may be from the bubbler and its connecting plumbing. This bubbler fixture is made of chrome plated brass and has a brass connector on the underside of the sink. The bubbler also has a chrome plated brass flow regulator installed between the operating valve and the outlet. The connecting plumbing is copper with lead solder and includes a brass shut off valve.

Replacement of this bubbler tap and its connection plumbing with lead free materials will significantly reduce lead exposure at this location. If replacement is not currently feasible, sample results indicate that flushing this tap for 3 minutes following periods of stagnation is likely to reduce lead concentrations and lead exposure.

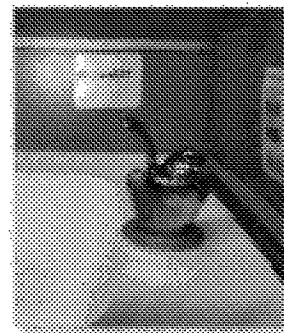
Results: P1=39 parts per billion, P2=14 parts per billion  
F01=11 parts per billion, F02=1 part per billion

These results suggest the highest contribution of lead may be from the bubbler and its connecting plumbing. This bubbler fixture is made of chrome plated brass and has a brass connector on the underside of the sink. Connecting plumbing in the cabinet under the sink is made up of brass connectors and copper piping with lead solder.

Replacement of this bubbler tap and its connection plumbing with lead free materials will significantly reduce lead exposure at this location. If replacement is not currently feasible, sample results indicate that flushing this tap for 3 minutes following periods of stagnation is likely to reduce lead concentrations and lead exposure.

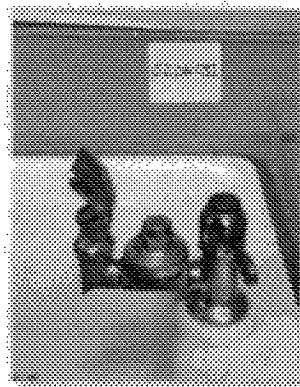
**Outlet: Bubbler Fountain (02DW031)**

Results: P1=84 parts per billion, P2=7 parts per billion  
F01=1 part per billion, F02=non-detect

These results suggest the highest contribution of lead may be from the bubbler and its connecting plumbing. This bubbler fixture is made of chrome plated brass and has a brass connector on the underside of the sink. The bubbler also has a chrome plated brass flow regulator installed between the operating valve and the outlet. Connecting plumbing in the cabinet under the sink should be checked for brass components and copper piping with lead solder.

Replacement of this bubbler tap and its connection plumbing with lead free materials will significantly reduce lead exposure at this location. If replacement is not currently feasible, sample results indicate that flushing this tap for 3 minutes following periods of stagnation is likely to reduce lead concentrations and lead exposure.

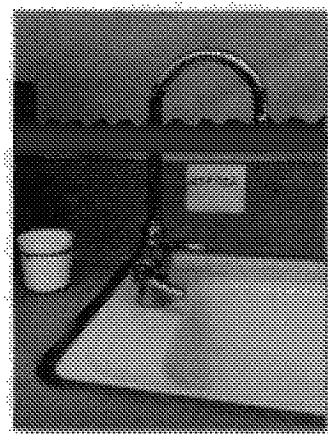
**Outlet: Sink Faucet (01CF016)**

Results: P1=402 parts per billion, P2=61 parts per billion  
F01=4 parts per billion, F02=1 part per billion

These results suggest the highest contribution of lead may be from the faucet and its connecting plumbing. The base of this faucet is chrome plated brass, and has a brass connection on the underside of the sink. Connecting plumbing in the cabinet under the sink is partly made up of brass connectors; copper piping with lead solder, and brass shut off valves.

Replacement of this faucet and its connection plumbing with lead free materials will significantly reduce lead exposure at this location. If replacement is not currently feasible, sample results indicate that flushing this tap for 3 minutes following periods of stagnation is likely to reduce lead concentrations and lead exposure.

This faucet also has an aerator/screen at the outlet. If the faucet is not replaced, the aerator/screen should be removed, inspected for particulate accumulations, scrubbed clean, and reinstalled. If particulates are found, the aerator/screen should be periodically checked and cleaned.

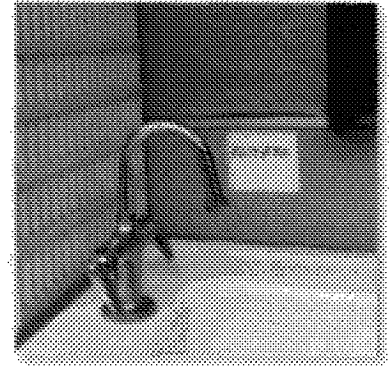
Results: P1=21 parts per billion, P2=23 parts per billion  
F01=5 parts per billion, F02=1 part per billion

These results suggest the highest contribution of lead may be from the faucet and its connecting plumbing. The base of this faucet is chrome plated brass, and has a brass connection on the underside of the sink. Connecting plumbing in the cabinet under the sink is partly made up of brass connectors; copper piping with lead solder, and brass shut off valves.

Replacement of this faucet and its connection plumbing with lead free materials will significantly reduce lead exposure at this location. If replacement is not currently feasible, sample results indicate that flushing this tap for 3 minutes following periods of stagnation is likely to reduce lead concentrations and lead exposure.

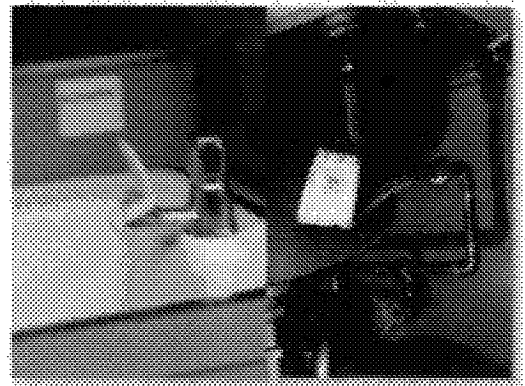
**Outlet: Bubbler Fountain (02DW033)**

Results: P1=20 parts per billion, P2=4 parts per billion  
F01=3 parts per billion, F02=3 parts per billion

These results suggest the highest contribution of lead may be from the bubbler and its connecting plumbing. Parts of this bubbler fixture are made of brass and it has a brass connector on the underside of the sink. Connecting plumbing in the cabinet under the sink is partly made up of brass connectors; copper piping with lead solder, and a brass shut off valve.

Replacement of this bubbler tap and its connection plumbing with lead free materials will significantly reduce lead exposure at this location. If replacement is not currently feasible, sample results indicate that flushing this tap for 3 minutes following periods of stagnation is likely to reduce lead concentrations and lead exposure.

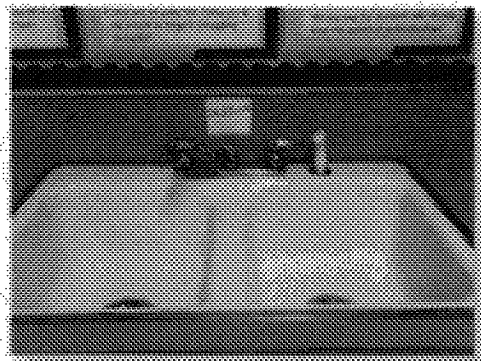
Results: P1=17 parts per billion, P2=5 parts per billion  
F01=4 parts per billion, F02=1 part per billion

These results suggest the highest contribution of lead may be from the faucet and its connecting plumbing. This fixture appears to be a Delta two handled faucet. This model faucet typically has a brass tube in its deck body and may contain some additional brass components. Connecting plumbing in the cabinet under the sink should be checked for brass components and copper piping with lead solder.

Replacement of this faucet and its connection plumbing with lead free materials will significantly reduce lead exposure at this location. If replacement is not currently feasible, sample results indicate that flushing this tap for 3 minutes following periods of stagnation is likely to reduce lead concentrations and lead exposure.

This faucet also has an aerator/screen at the outlet. If the faucet is not replaced, the aerator/screen should be removed, inspected for particulate accumulations, scrubbed clean, and reinstalled. If particulates are found, the aerator/screen should be periodically checked and cleaned.

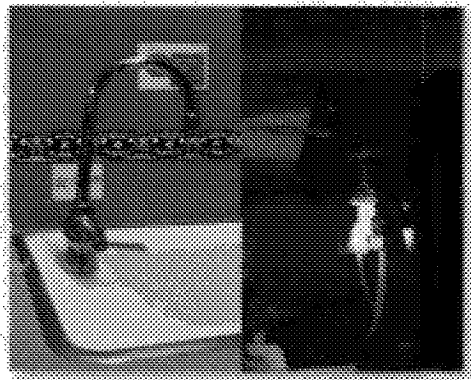
Results: P1=7 parts per billion, P2=21 parts per billion  
F01=5 parts per billion, F02=1 part per billion

These results suggest the highest contribution of lead may be from the faucet and its connecting plumbing. The base of this faucet is chrome plated brass, and has a brass connection on the underside of the sink. Hot and cold water lines connect to this faucet with a brass mixer fitting under the sink. Connecting plumbing in the cabinet under the sink may also contain additional brass connectors and copper plumbing with lead solder.

Replacement of this faucet and its connection plumbing with lead free materials will significantly reduce lead exposure at this location. If replacement is not currently feasible, sample results indicate that flushing this tap for 3 minutes following periods of stagnation is likely to reduce lead concentrations and lead exposure.

This faucet also has an aerator/screen at the outlet. If the faucet is not replaced, the aerator/screen should be removed, inspected for particulate accumulations, scrubbed clean, and reinstalled. If particulates are found, the aerator/screen should be periodically checked and cleaned.

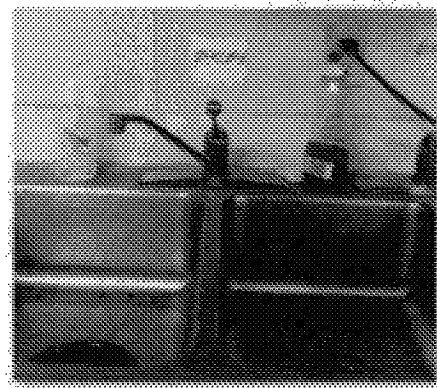
Results: P1=17 parts per billion, P2=3 parts per billion  
F01=2 parts per billion, F02=3 parts per billion

These results suggest the highest contribution of lead may be from the faucet and its connecting plumbing. The faucet is a Delta 400. This model faucet valve has brass components. This style faucet also has a mixing valve that may allow mixing of hot and cold water. Connecting plumbing in the cabinet under the sink may also contain brass components.

Replacement of this faucet and its connection plumbing with lead free materials will significantly reduce lead exposure at this location. If replacement is not currently feasible, sample results indicate that flushing this tap for 3 minutes following periods of stagnation is likely to reduce lead concentrations and lead exposure.

This faucet also has an aerator/screen at the outlet. If the faucet is not replaced, the aerator/screen should be removed, inspected for particulate accumulations, scrubbed clean, and reinstalled. If particulates are found, the aerator/screen should be periodically checked and cleaned.

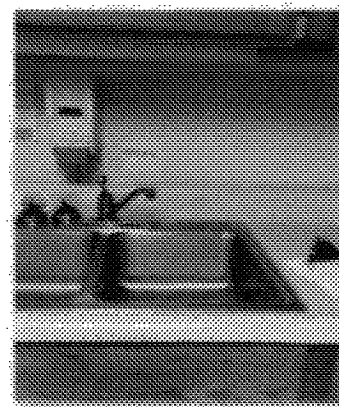
Location: Outbuilding Unit 1, Proposed Preschool

Results: P1=0.33 parts per million, P2=1.84 parts per million  
F01=1.07 parts per million, F02=1.12 parts per million
